Perfect Inspections

CONFIDENTIAL INSPECTION REPORT

123 Anywhere St, Fresno, CA 93711

4/3/2009

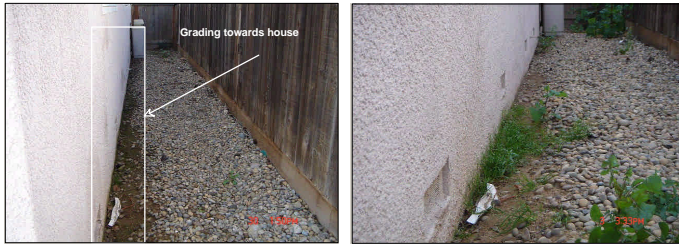
There are areas where water will be directed toward the house instead of away from it, as recommended. This not only allows for the possibility of moisture intrusion but also differential settling, et cetera. Side yard of house should be graded away from house.

There are areas where water is directed toward the house instead of away from it - *Continued*

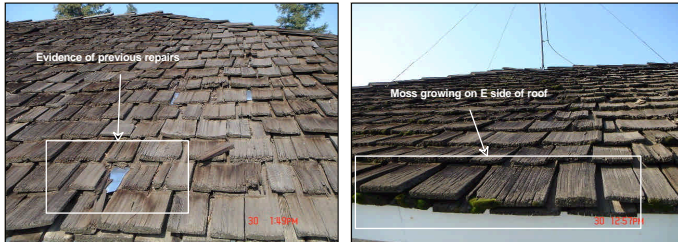
The roof looks to be the original roof and appears to have been previously repaired

The roof needs to be serviced for the following reasons: Because the roof is the original wood shingle and may be 25-30 years old there is obvious deficiencies. This service should be scheduled well before the close of escrow, because additional defects could be revealed by a specialist, and our service does not include any guarantee against leaks. For a guarantee, a roofing company would have to perform a water-test and issue a roof certification.
